# Historic Architecture Reconnaissance Survey

August 2017

## Eight Point Wind Energy Center, Allegheny and Steuben County, New York

Project Review No. 16PR00701

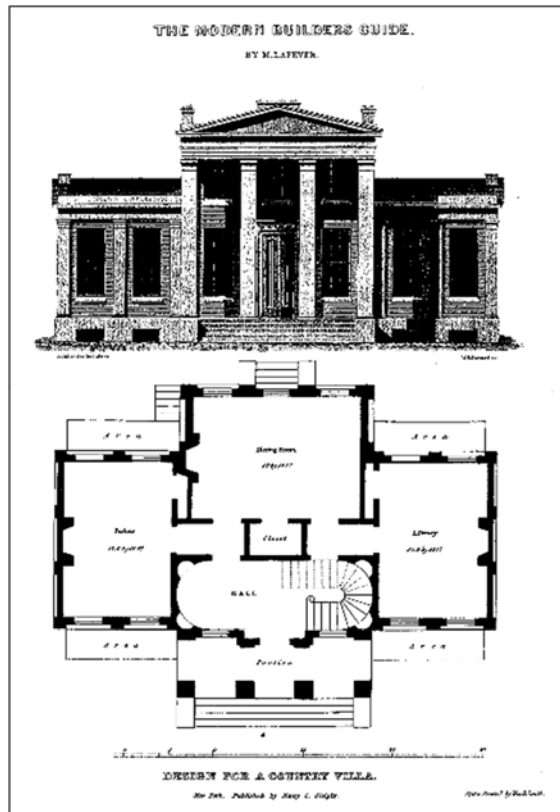
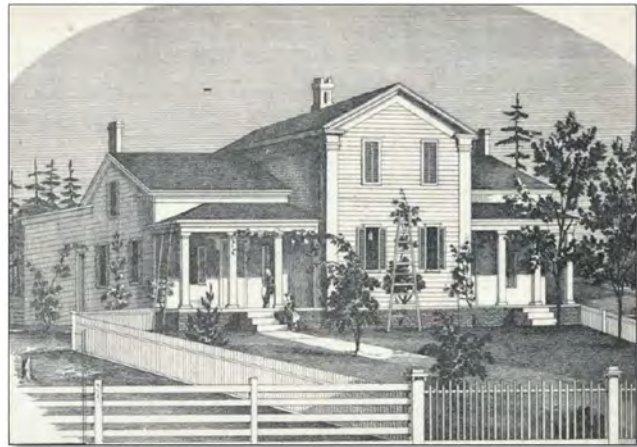
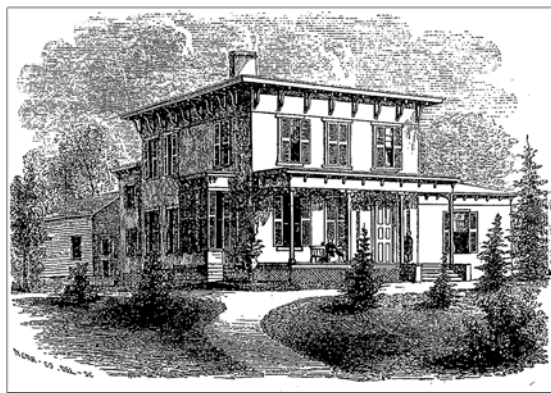
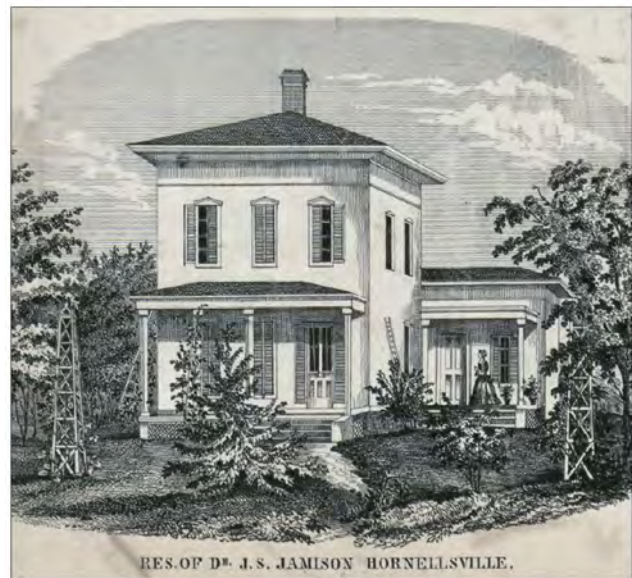
**Figure 5-3:** Plates from popular pattern books served as sources for rural and village residences throughout Allegany and Steuben County, New York. These included Lafever’s *The Modern Builder’s Guide* (1833; top left) and the *American Agriculturalist* (1859; bottom left) (Guter and Foster 1992). Common local adaptations from Allegany and Steuben County appear at right (Bechler 1856; Levy 1857).

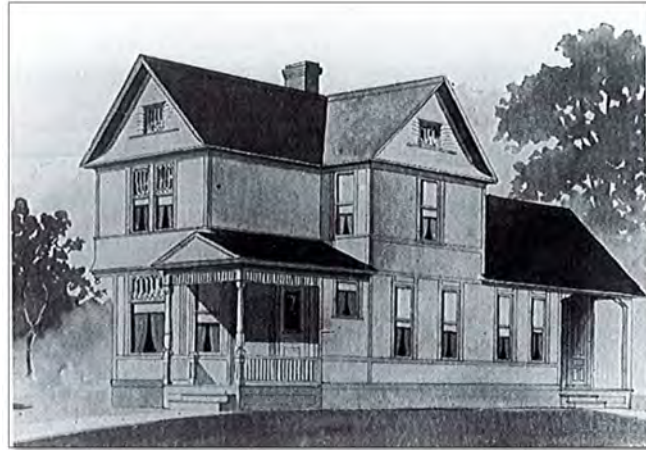
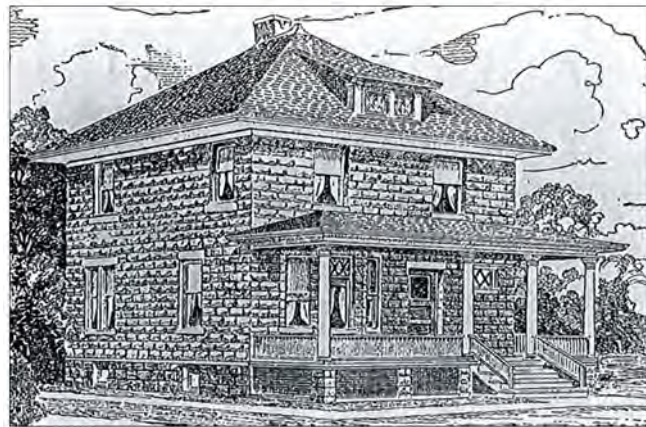
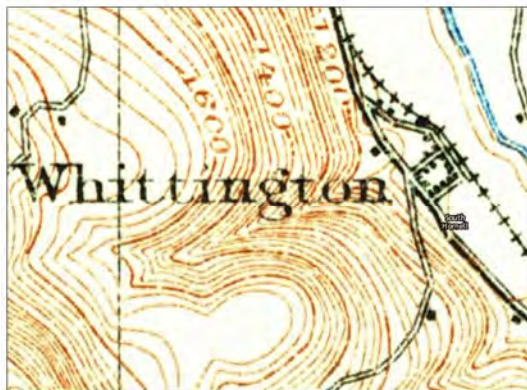
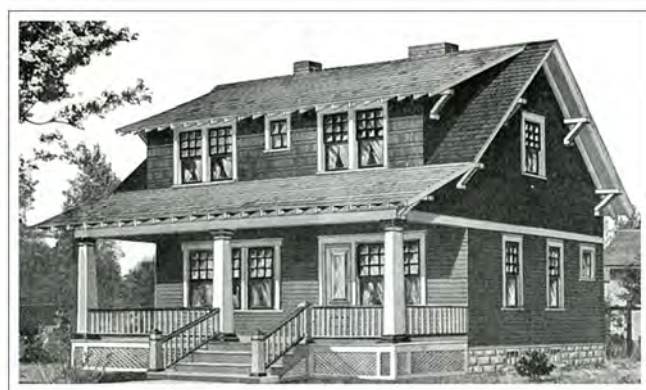
**Figure 5-5:** These common late nineteenth-century residential designs, available from mail-order suppliers, such as Sears Roebuck & Company, Radford, and Aladdin, appeared throughout Allegany and Steuben County in rural places, villages, and new streetcar suburbs, such as Whittington (Reiff 2000; USGS 1915).

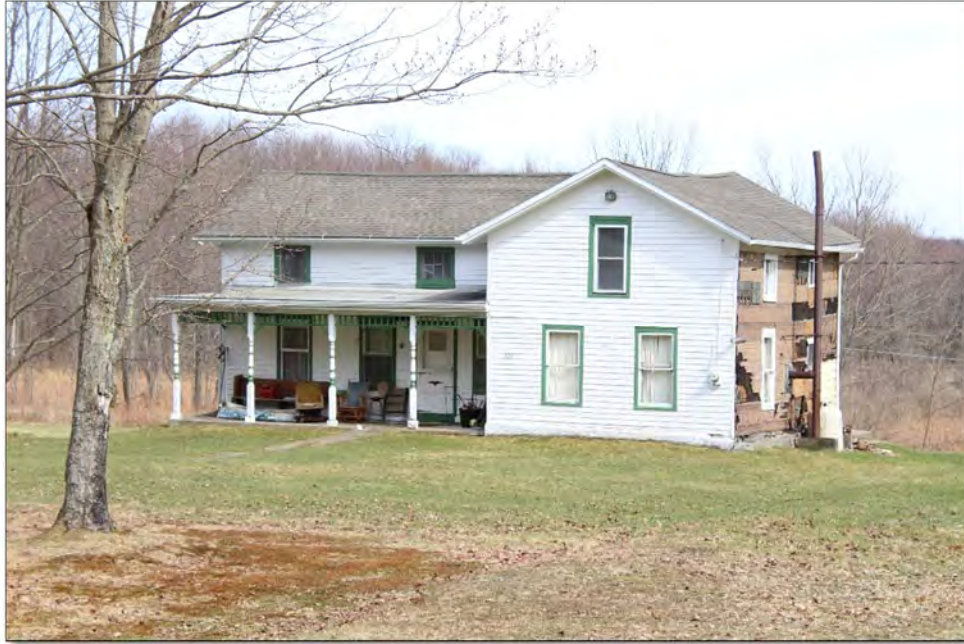
**Photo 7.1:** This common wood-framed vernacular residence with side wing typified most farmhouses (TRC# 1815) (Philip A. Hayden, April 3, 2017, Image# 204).

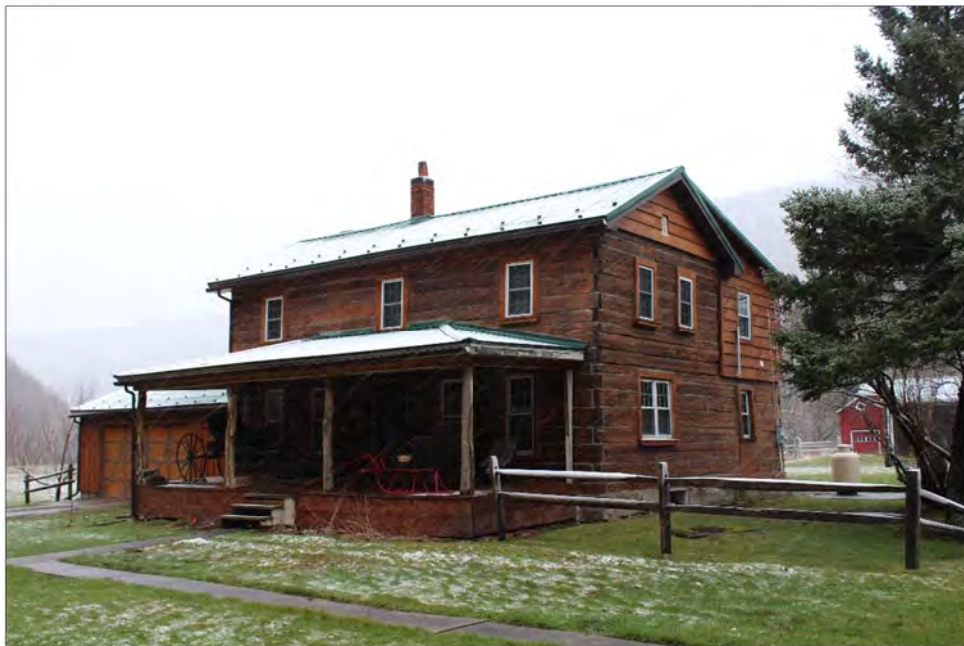
**Photo 7.2:** This exposed cut log house with false-corner construction comprised the only identified building of log construction (TRC# 1288) (Philip A. Hayden, April 7, 2017, Image# 765).

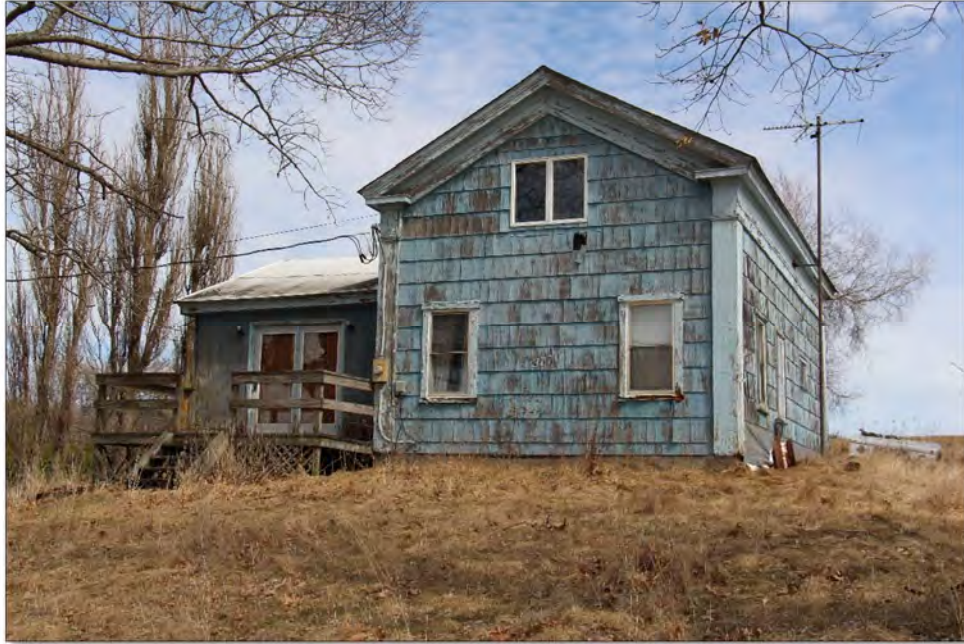
**Photo 7.3:** Typical vernacular Greek Revival-style farmhouse with wing (TRC# 1103) (David Price, April 3, 2017, Image# 1511).

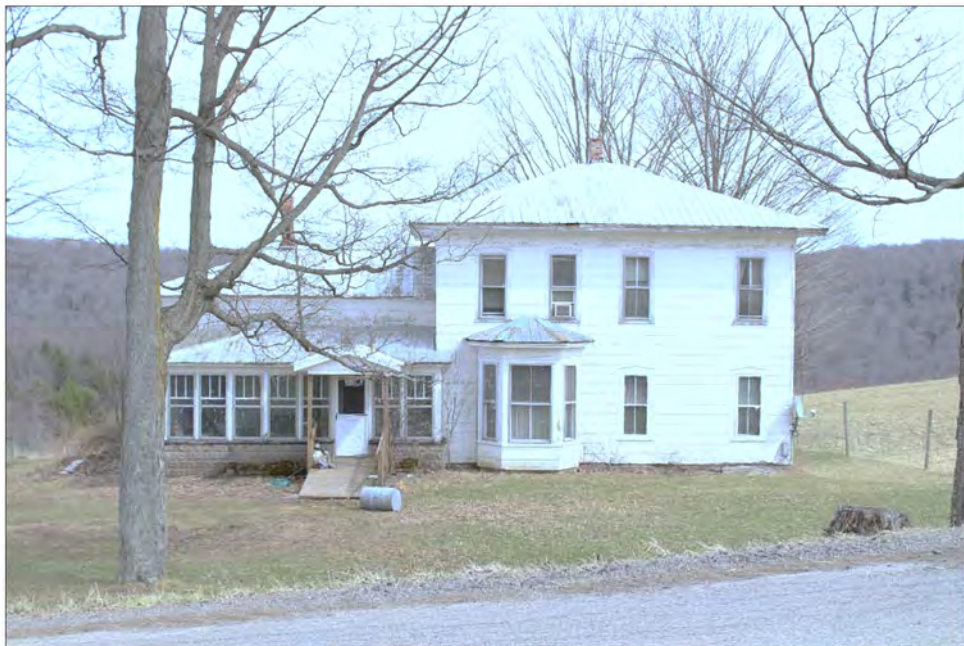
**Photo 7.4:** Typical vernacular hipped roof Italianate-style farmhouse with wing (TRC# 1751) (Philip A. Hayden April 3, 2017, Image# 185).

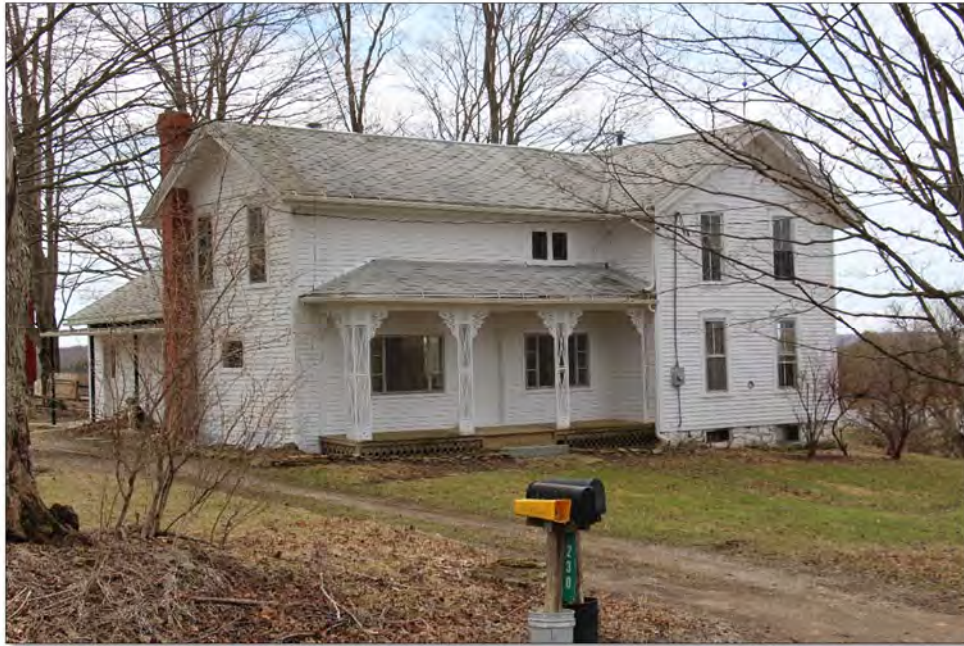
**Photo 7.5:** Typical vernacular gable roof Italianate-style farmhouse with wing (TRC# 1194) (David Price, April 3, 2017, Image# 1470).

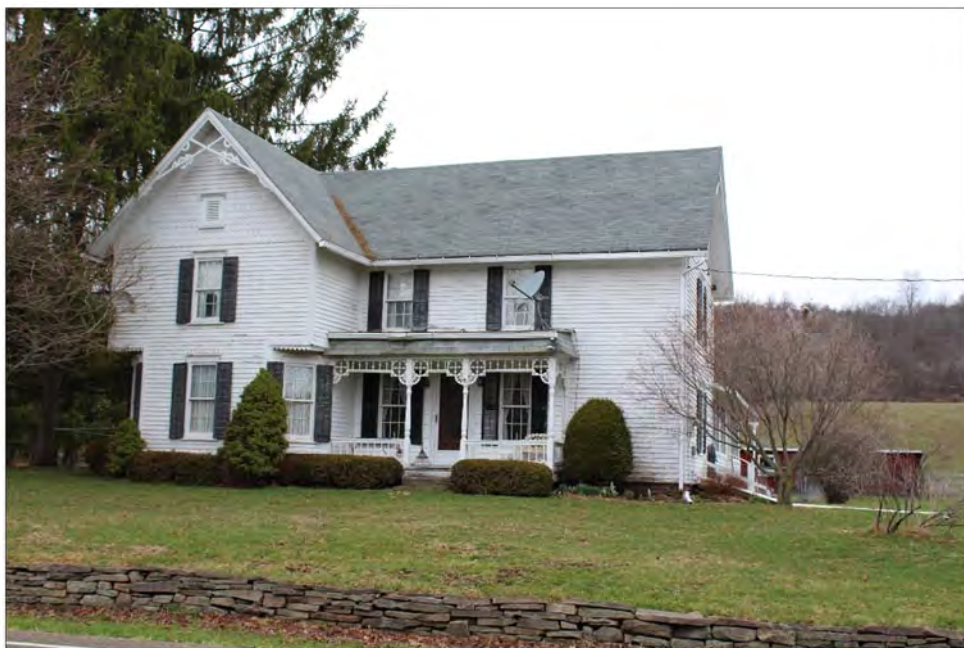
**Photo 7.6:** Typical vernacular Queen Anne-style farmhouse with wing (TRC# 1686) (Philip A. Hayden, April 6, 2017, Image# 693).

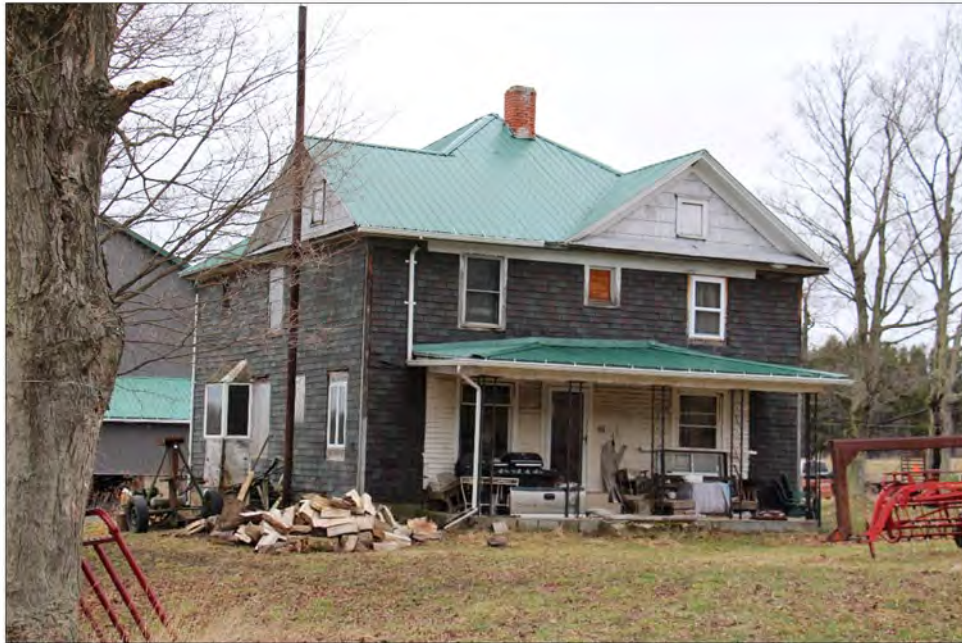
**Photo 7.7:** Typical asymmetrical Queen Anne-style mail-order farmhouse reminiscent of models available through Sears (TRC# 1155) (David Price, April 5, 2017, Image# 1775).

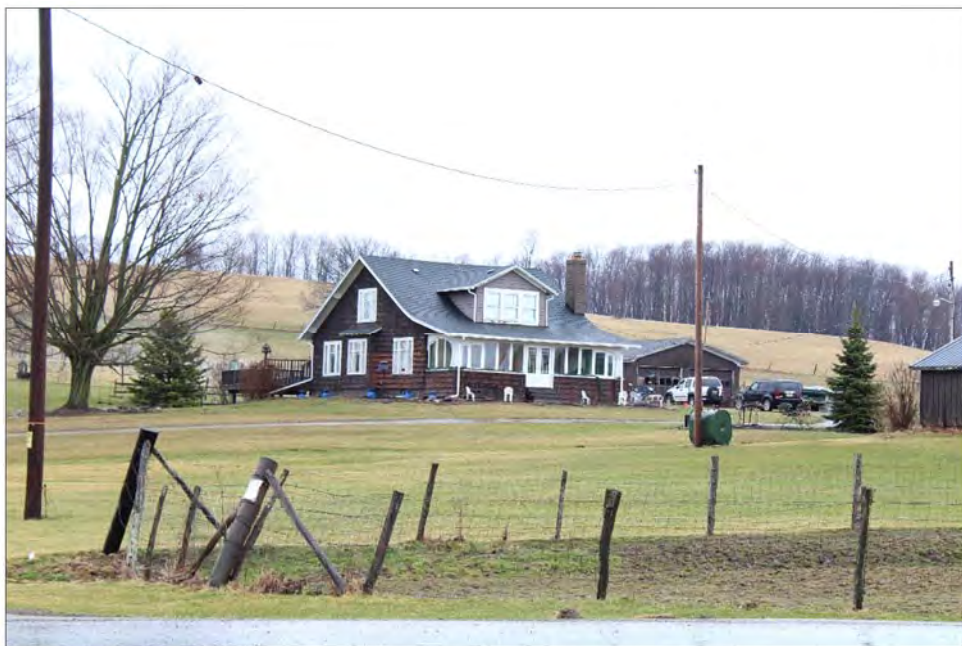
**Photo 7.8:** Typical Craftsman-style mail-order farmhouse, reminiscent of “The Grange,” available through Aladdin (TRC# 1808) (Philip A. Hayden, April 4, 2017, Image# 223).

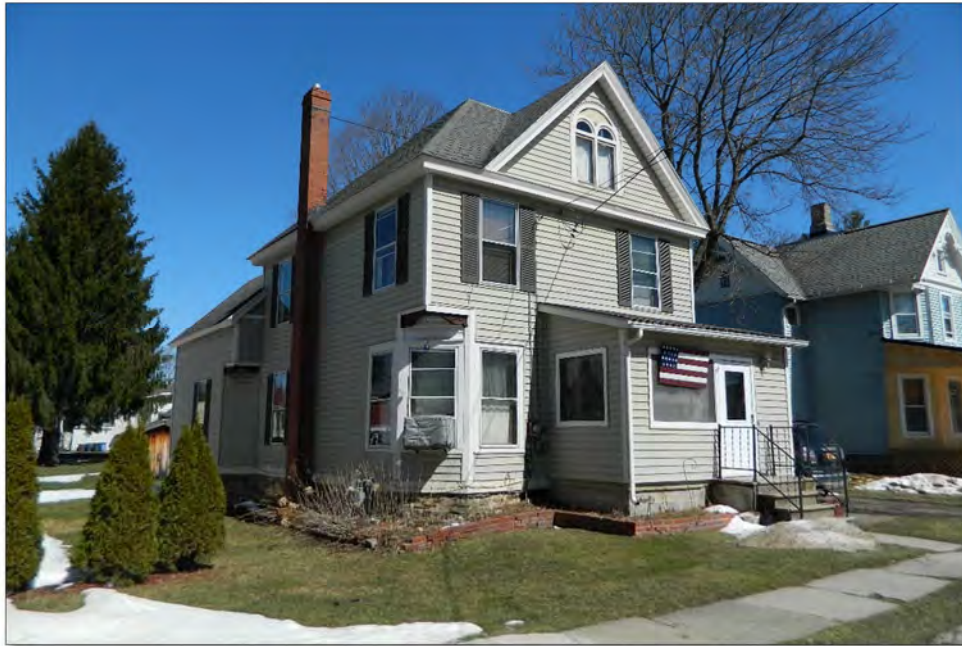
**Photo 7.9:** Typical asymmetrical Queen Anne-style mail-order residence, Village of Andover (TRC# 1854) (Jessica Burr, March 21, 2017, Image# 9370).

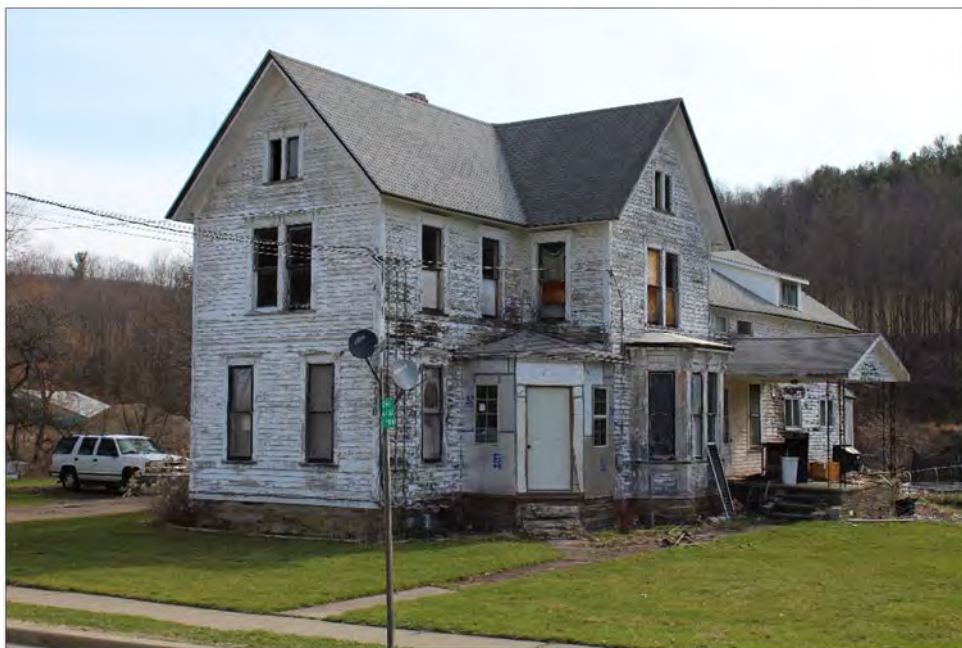
**Photo 7.10:** Typical asymmetrical Queen Anne-style mail-order residence, Village of Greenwood (TRC# 1233) (Philip A. Hayden, April 3, 2017, Image# 82).

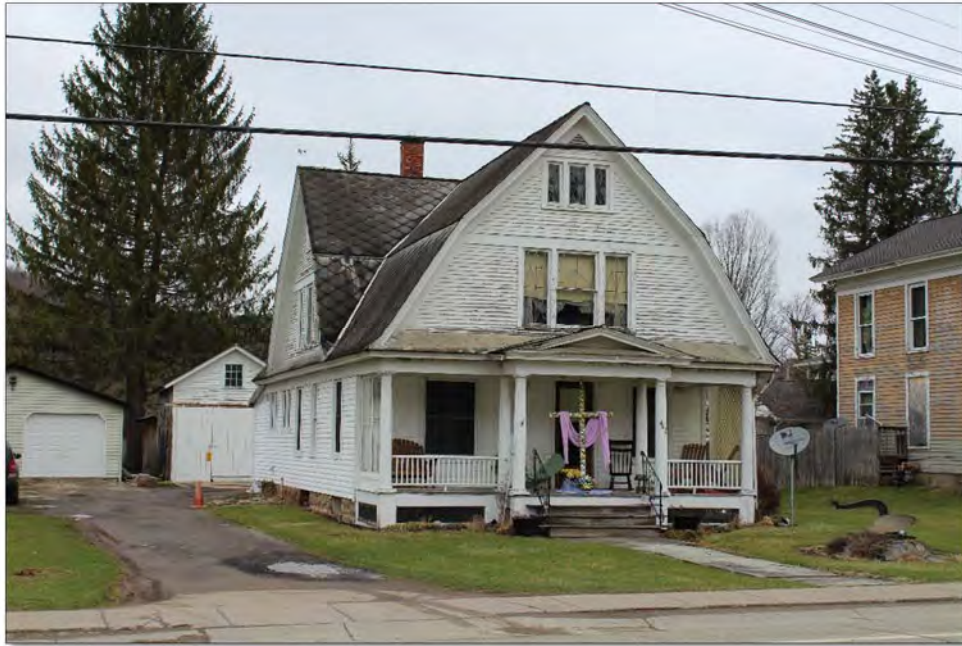
**Photo 7.11:** Typical Gambrel roof Dutch Colonial Revival-style mail-order residence, Village of Whitesville (TRC# 1499) (Philip A. Hayden, April 5, 2017, Image# 417).

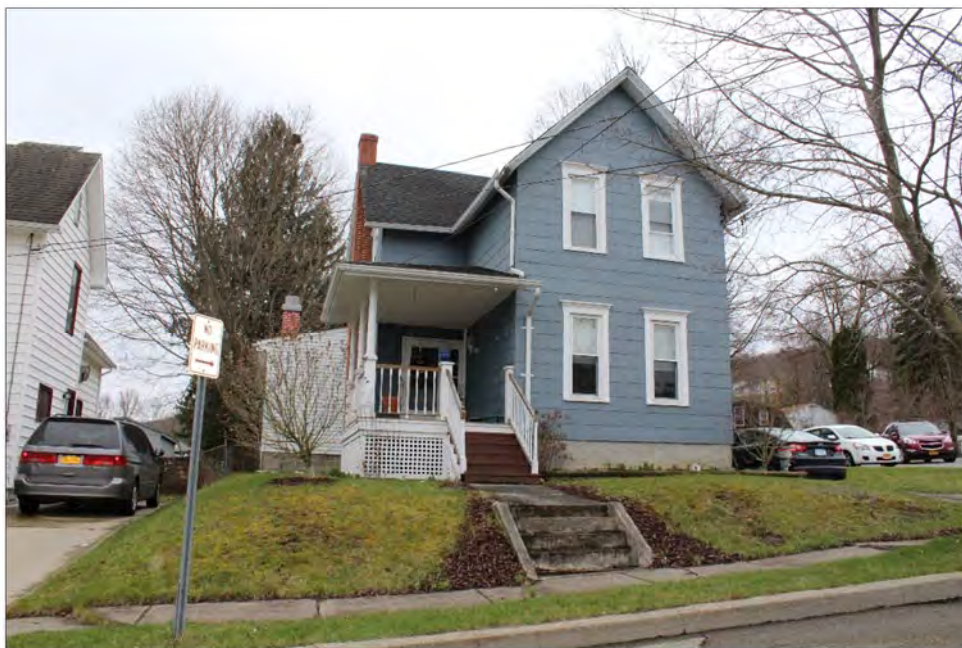
**Photo 7.12:** Typical asymmetrical Queen Anne-style mail-order residence, City of Hornell (TRC# 1089) (Philip A. Hayden, April 7, 2017, Image# 890).

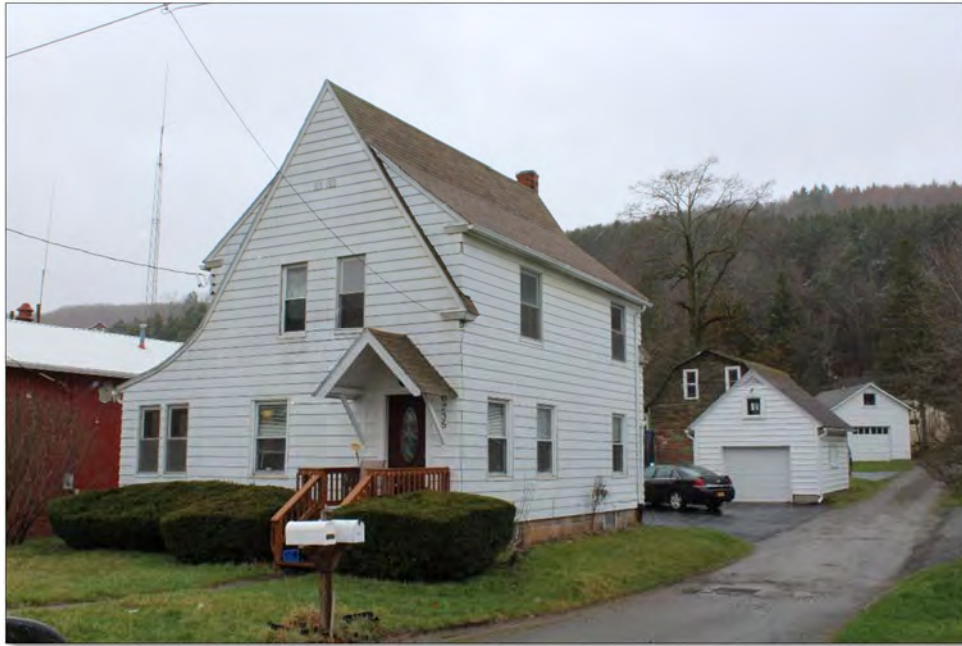
**Photo 7.13:** Typical English Cottage-style mail-order residence, City of Hornell (TRC# 1345) (Philip A. Hayden, April 7, 2017, Image# 840).

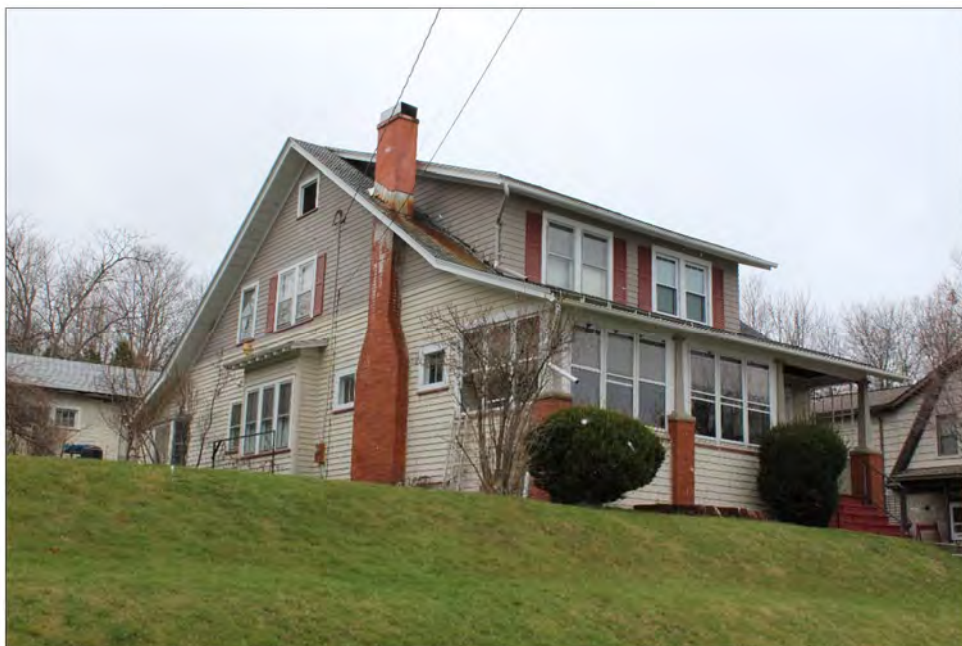
**Photo 7.14:** Typical Craftsman-style mail-order bungalow, City of Hornell (TRC# 1061) (Philip A. Hayden, April 7, 2017), Image# 916).

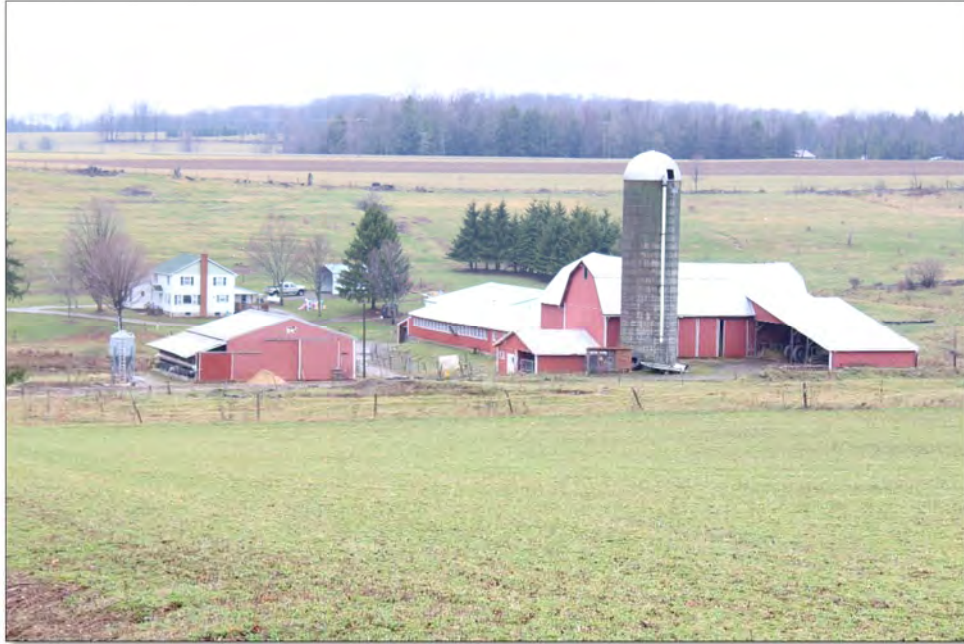
**Photo 7.15:** Typical active farmstead with a multi-faceted barn complex composed of a gambrel roof main barn and numerous attached sections of various ages (TRC# 1772) (Philip A. Hayden, April 4, 2017, Image# 258).

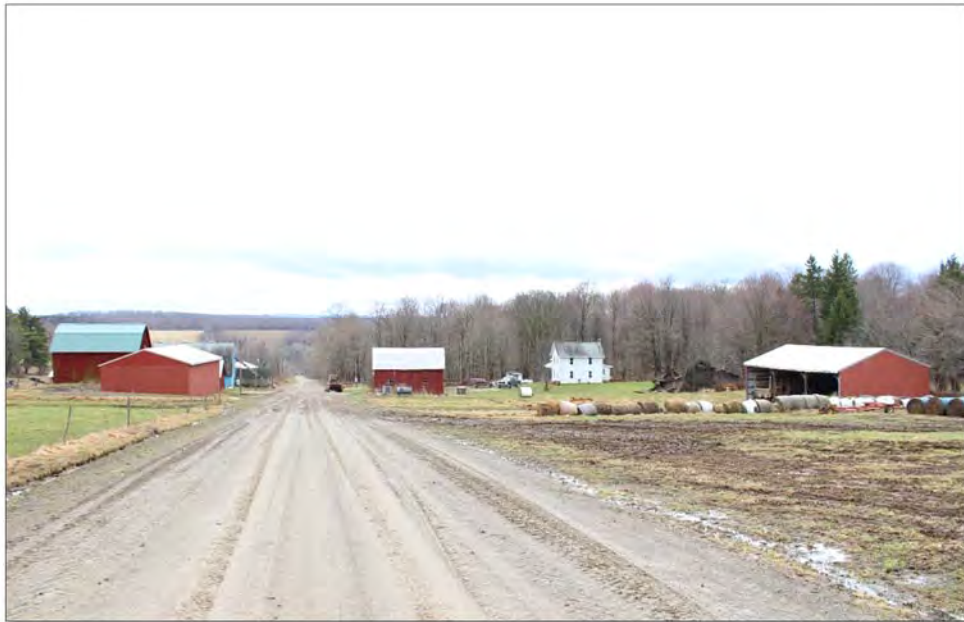
**Photo 7.16:** Typical active farmstead straddling both sides of the road with scattered outbuildings of various ages (TRC# 1754) (Philip A. Hayden, April 4, 2017, Image# 303).

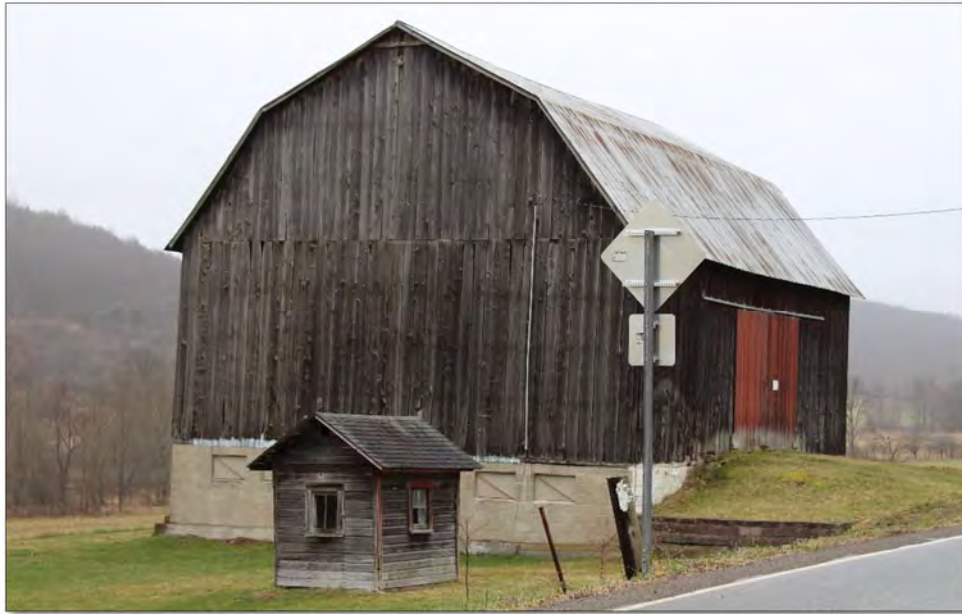
**Photo 7.17:** Typical late nineteenth- or early twentieth-century side gambrel barn on a high basement. This form is the most common to the survey area (TRC# 1680) (Philip A. Hayden, April 6, 2017, Image# 720).

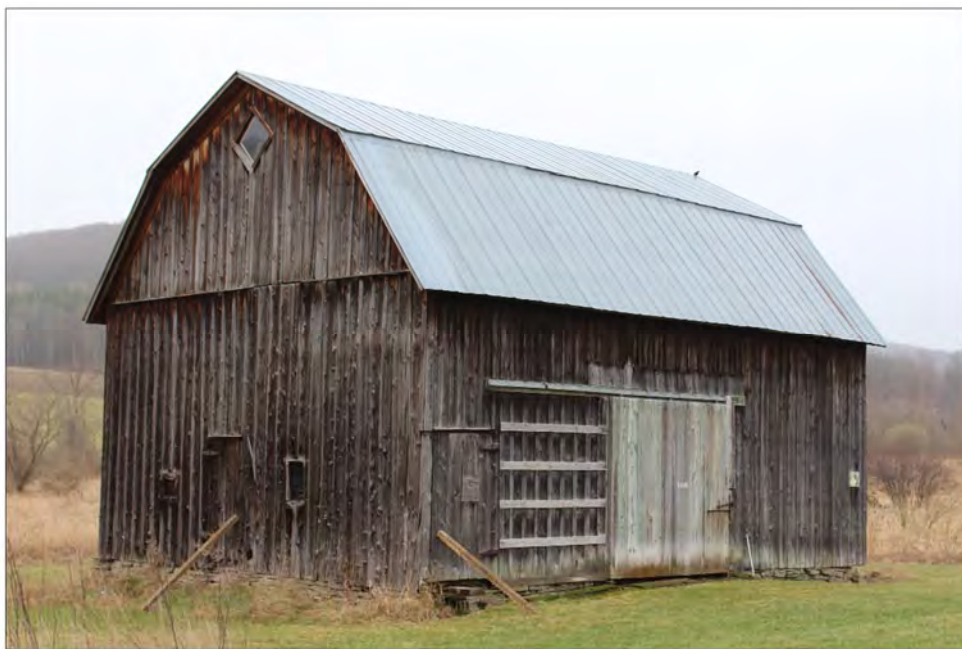
**Photo 7.18:** Typical late nineteenth- or early twentieth-century side gambrel barn on ground-level foundation (TRC# 1694) (Philip A. Hayden, April 6, 2017, Image# 721).

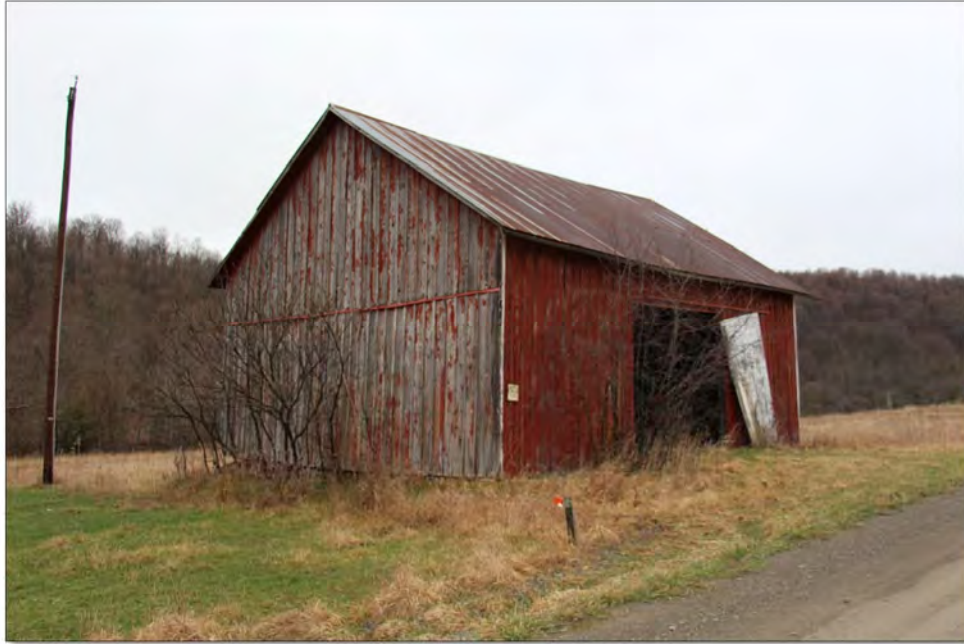
**Photo 7.19:** Typical mid- to late nineteenth-century side gable barn on ground-level foundation (TRC# 1702) (David Price, April 6, 2017, Image# 1908).

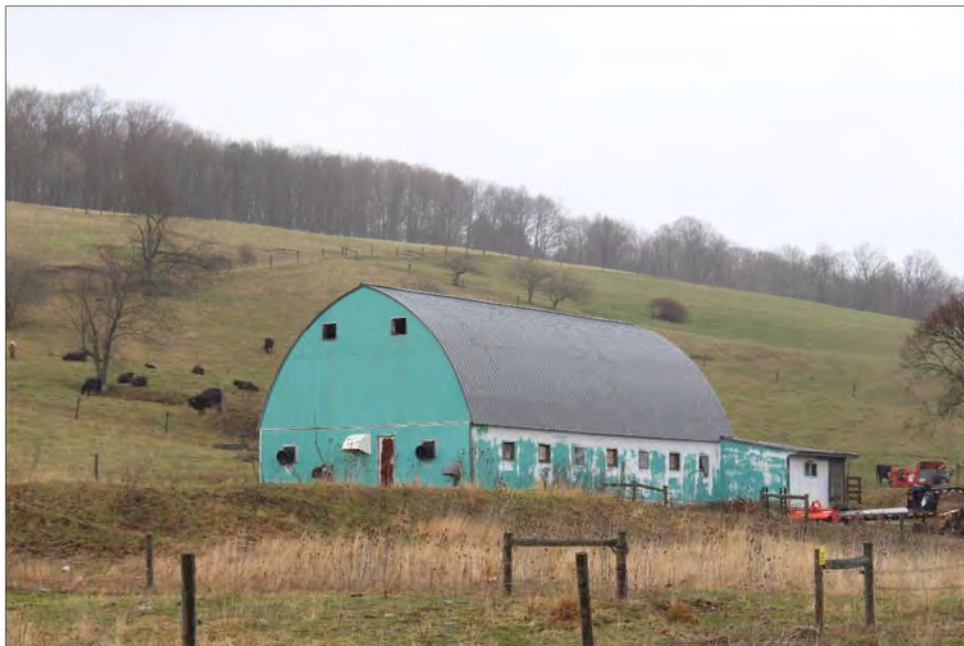
**Photo 7.20:** A relatively rare example of a twentieth-century Gothic roof barn available through mail-order suppliers (TRC# 1781) (Philip A. Hayden, April 4, 2017, Image# 326).

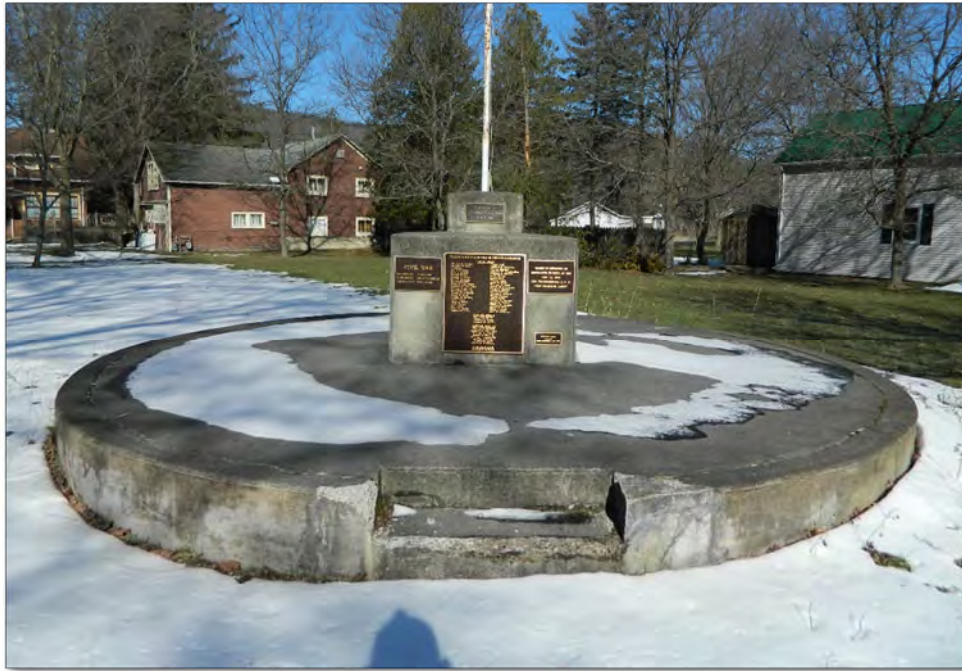
**Photo 7.21:** A 1960 Memorial to Veterans of all wars, Village of Andover (TRC# 1895) (Jessica Burr, March 23, 2017, Image# 9662).

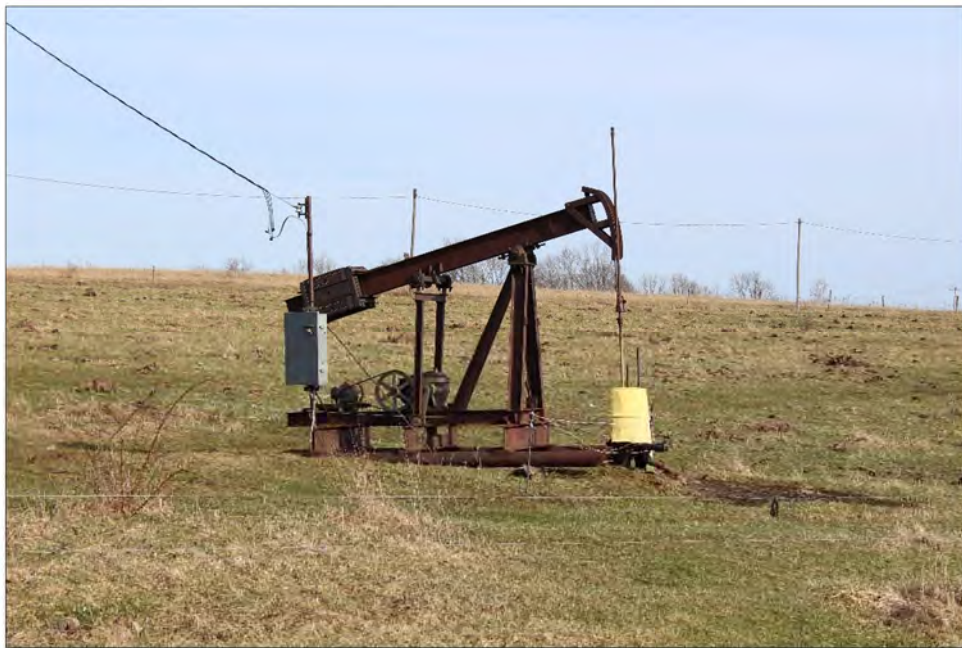
**Photo 7.22:** A typical oil pump found throughout the study area, located off of Harrigan Gully Road, Independence (Not Surveyed) (Philip A. Hayden, April 5, 2017, Image# 621).

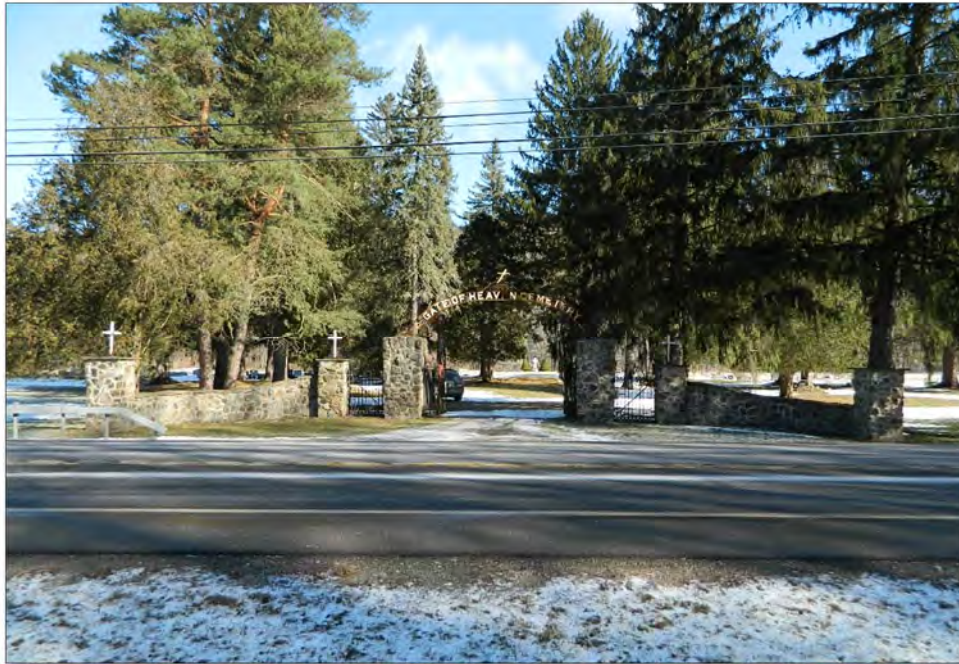
**Photo 7.23:** Gate of Heaven Roman Catholic Cemetery entrance, established 1930 near the Village of Andover (TRC# 1042) (Philip A. Hayden, March 22, 2017, Image# 9517).

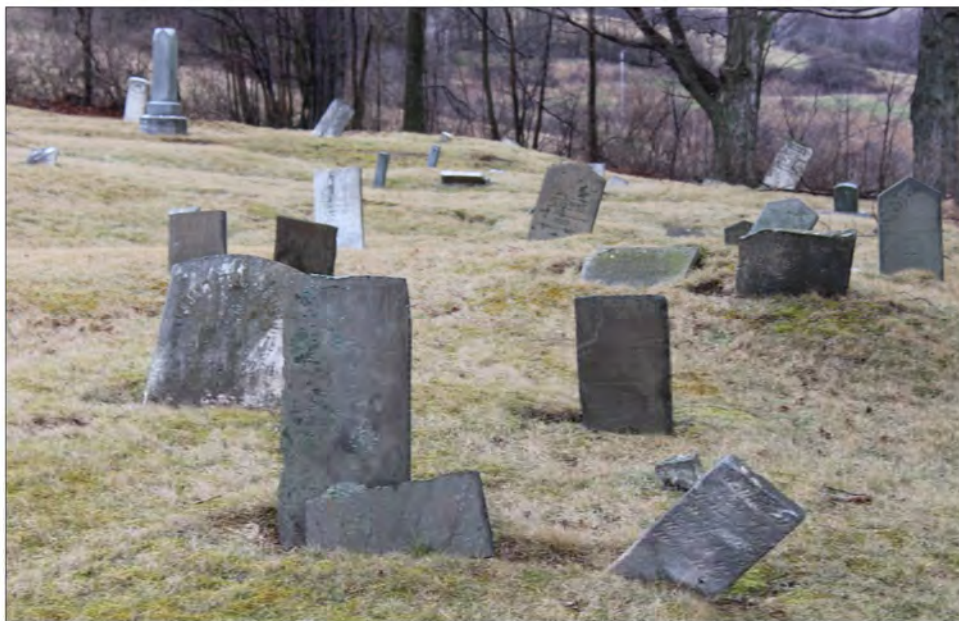
**Photo 7.24:** The Potter Family cemetery in Troupsburg, typical of the surveyed rural cemeteries, includes markers dating from the 1850s to the early twentieth-century. Most surveyed cemeteries were unidentified (TRC# 1717) (Philip A. Hayden, April 6, 2017, Image# 686).

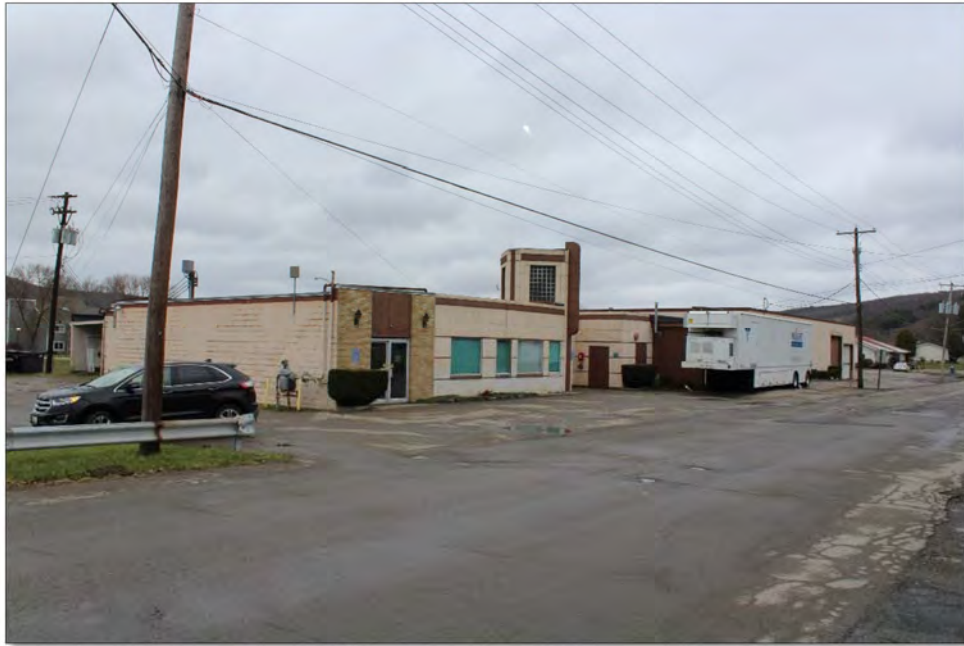
**Photo 7.25:** An altered c. 1945 commercial laundry, City of Hornell (TRC# 1064) (Philip A. Hayden, April 7, 2017, Image# 872).

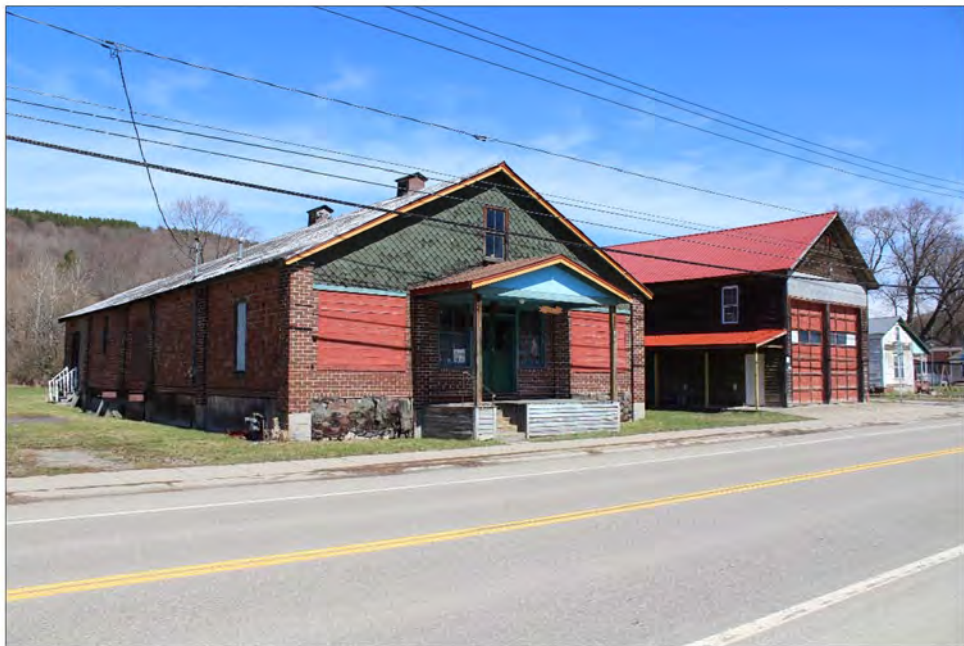
**Photo 7.26:** A c. 1910 commercial feed mill and store complex, Whitesville (TRC# 1474) (David Price, April 5, 2017, Image# 526).

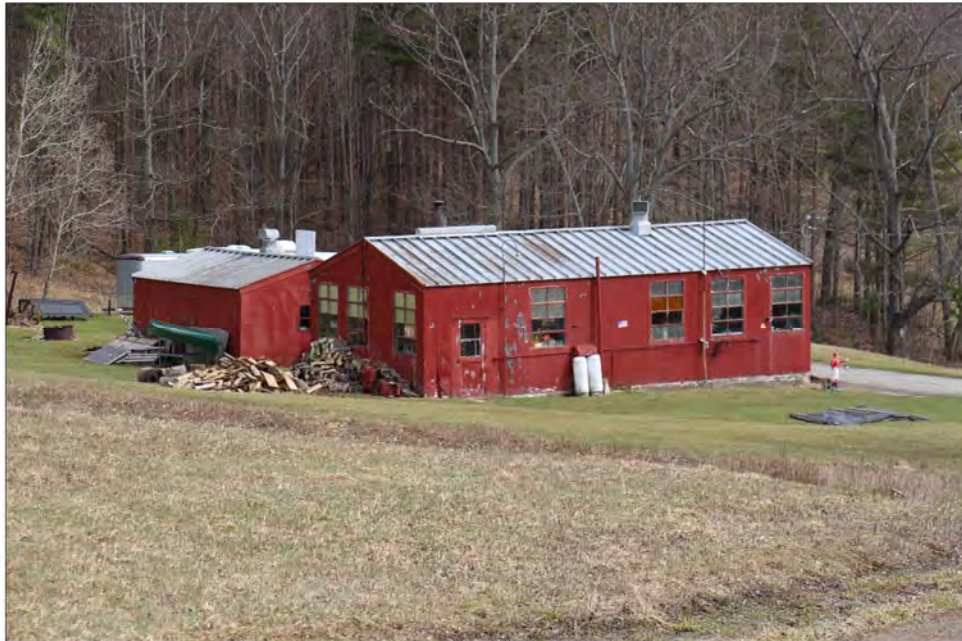
**Photo 7.27:** A c. 1960 gas compressor station, Greenwood (TRC# 1171) (David Price, April 3, 2017, Image# 1549).

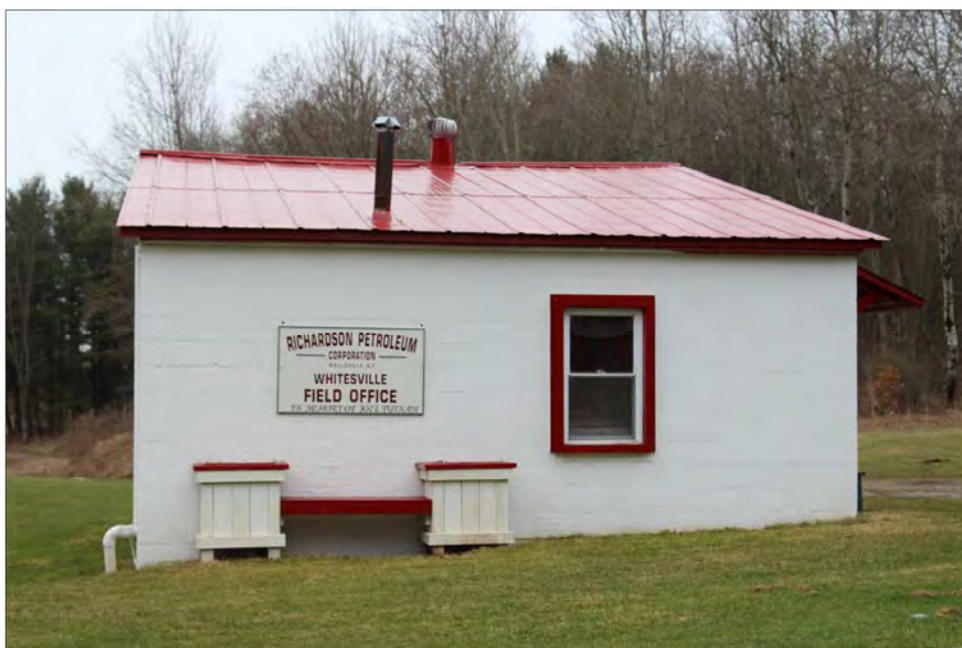
**Photo 7.28:** The c. 1935 Richardson Petroleum Corporation's Whitesville Field Office (TRC# 1408) (Philip A. Hayden, April 6, 2017, Image# 652).

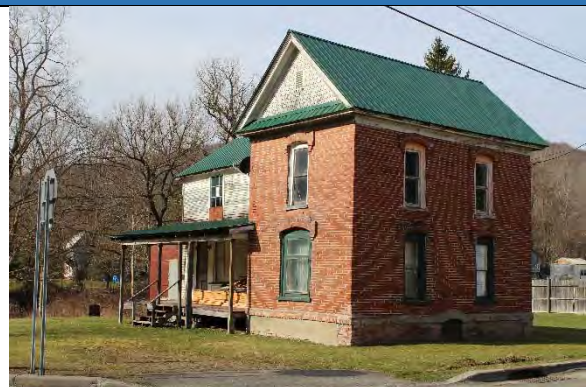
10114.000014 (10114.000046)	Residence	Brick Queen Anne Residence	2635 SR 248	Greenwood	Steuben	Eligible	Criterion C/Architecture Replaced side porch. Retains overall integrity	Eligible
17

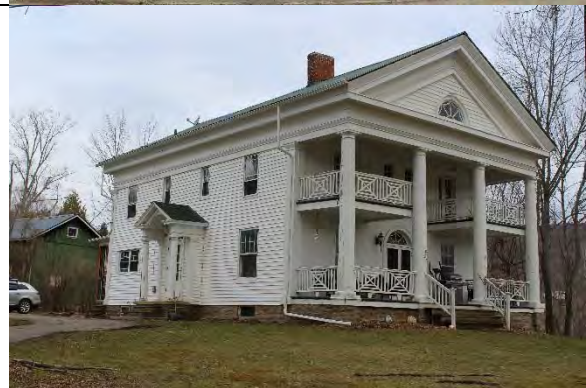
10114.000036	Residence	N/A	1467 Church Hill Rd	Greenwood	Steuben	Eligible	Criterion C/Architecture Retains overall integrity	Eligible
18

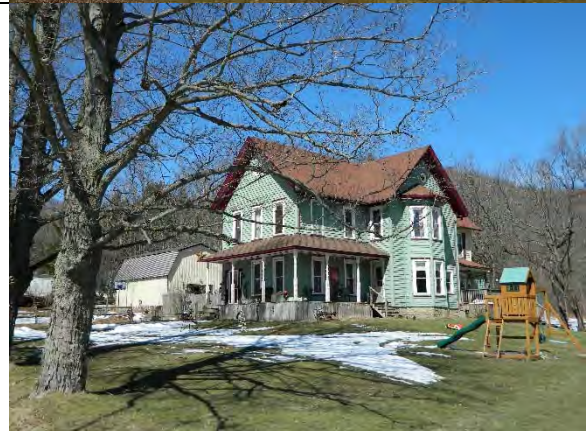
10130.000001	Residence	Freberg House	1750 Cemetery Hill Rd	West Union	Steuben	Eligible	Criterion C/Architecture <sup>2</sup> Replaced windows, front porch, front door, and door surround; shutters removed. Diminished integrity	Not Eligible

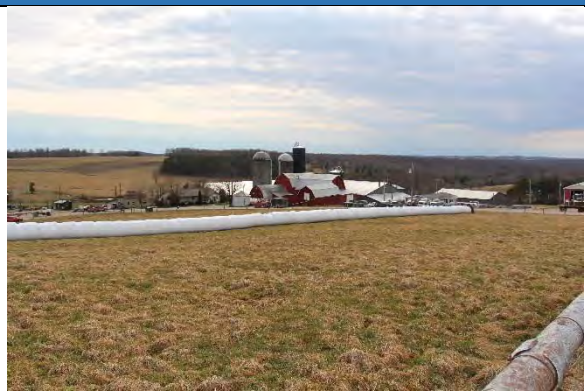
10114.000043	Farmsteads	Multiple Resources	558 Lane School Rd	Greenwood	Steuben	Unevaluated	Potentially eligible under Criteria A & C/Agriculture, Architecture & Criterion Consideration D/Exploration/Settlement. Multiple construction dates; multiple styles. Comprises four distinct resources: 558 Lane School Rd, 491 Lane School Rd, 2835 CR 61, and the Krusen Family Cemetery on CR 61. Includes common forms, extensively altered residences and outbuildings with many replacement windows, artificial siding, and altered fenestration. The cemetery does not contain known individuals of transcendent importance, great age, distinctive design features, or associations with historical events. Lacks significance and/or integrity	Not Eligible

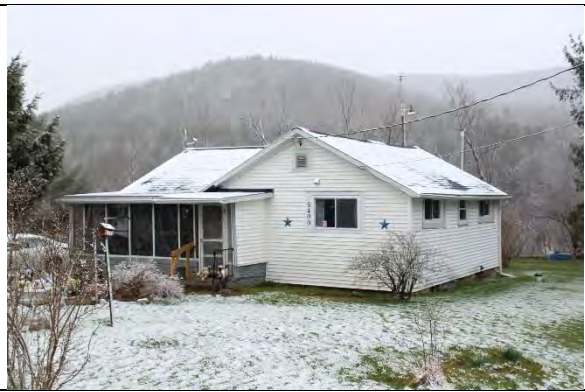
10115.000007	Residence		5400 CR 28 Purdy Creek Rd	Hartsville	Steuben	Unevaluated	Potentially eligible under Criterion C/Agriculture, Architecture. Built c. 1950. Minimal Traditional style. Common form. Replaced windows; vinyl siding throughout. Lacks significance and/or integrity	Not Eligible
11	N/A	No Image	10117.000004	Farmstead		South Side, Van Campen Rd	Hornellsville	Steuben	Unevaluated	<b>Un-located/ Assumed Demolished</b>	N/A
12	N/A	No Image	10117.000003	Greenhouse		CR 64	Hornellsville	Steuben	Unevaluated	<b>Un-located/ Assumed Demolished</b>	N/A
