# Historic Architecture Reconnaissance Survey

August 2017

## Eight Point Wind Energy Center, Allegheny and Steuben County, New York

Project Review No. 16PR00701

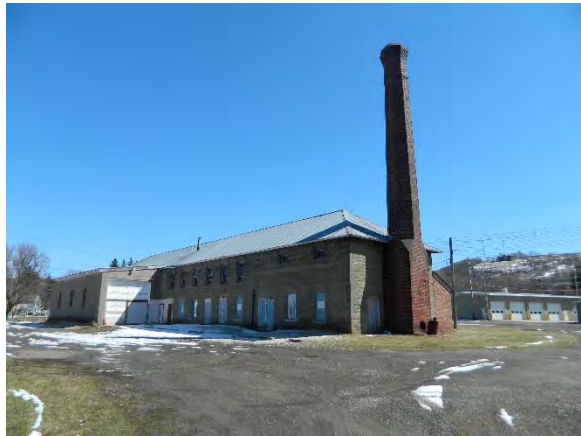
N/A	Commercial/Industrial	Brown & Bailey Milk Condensory	Depot St	Andover	Allegany	N/A	Potentially eligible under Criteria A & C/Agriculture, Architecture.  Built in 1908, this utilitarian rusticated cast concrete block building retains much of its original form, distinctive wall material, smooth concrete quoining, and imposing octagonal brick chimney stack. Some original six-light wooden window sash survive, however, most of the fenestration, doors, and windows have been extensively altered or closed up. Three original roof ventilators have been removed. The building includes a c. 1965 loading dock addition designed to accommodate milk tanker trucks. The heavily altered setting includes the loss of the original rail siding, and the addition of a large surrounding electrical substation. Although an example of an increasingly rare type, the building's diminished integrity of setting, design, materials, and workmanship no longer conveys the feeling of an early twentieth-century milk condensory or its associations with the industrialization of milk production, processing, and transport in New York.	Not Eligible

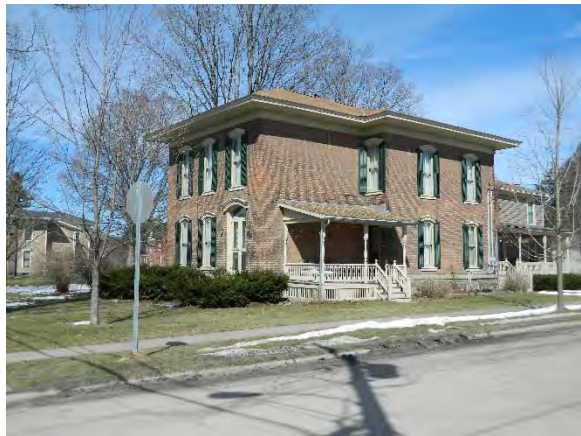
N/A	Residence	Van Sickle House (Mustard Seed Inn Bed & Breakfast)	13 East Center St	Andover	Allegany	N/A	Potentially eligible under Criterion C/Architecture.  Built c. 1870, the Italianate-style brick building features its original form, denticulated cornice, arched window caps, sash, louvered shutters, doors, finished stone foundation belt-course, and rubble stone foundation walls. The side porch is a slightly reconfigured modern reconstruction. A c. 1910, two-story frame and clapboard addition (former office) extends off the rear. The property includes a two-bay frame carriage house and large corner lot. The residence embodies the distinctive characteristics of its type, period, and method of construction. It retains a high degree of integrity of location, design, setting, materials, and workmanship. It conveys the feeling of a late nineteenth-century prosperous village residence and its associations with the spread of popular architectural styles in rural Steuben County.	Eligible

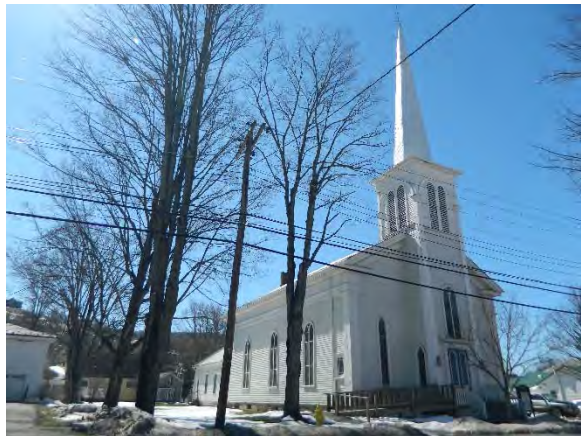
N/A	Church	Andover Presbyterian Church	34 East Greenwood St	Andover	Allegany	N/A	Potentially eligible under Criterion Consideration A/Architecture.  Built in 1868, this Carpenter Gothic-style church with Italianate and Greek Revival elements retains its original overall form, denticulated cornice, entablature, corner pilasters, wood clapboard siding, tower, belfry and spire. It also retains its original pointed gothic and round-arch stained glass windows with wood muntin sash and stained glass, as well as its two-leaf paneled door.  Alterations include a later patterned metal roof; modern front stoop, steps, handicap ramp, and miscellaneous rear additions. A well-preserved example of church architecture, it possesses its integrity of location, design, setting, materials, and workmanship. The building conveys the feeling of a distinguished piece of mid-nineteenth-century ecclesiastical architecture and its associations with the religious life of the community.	Eligible

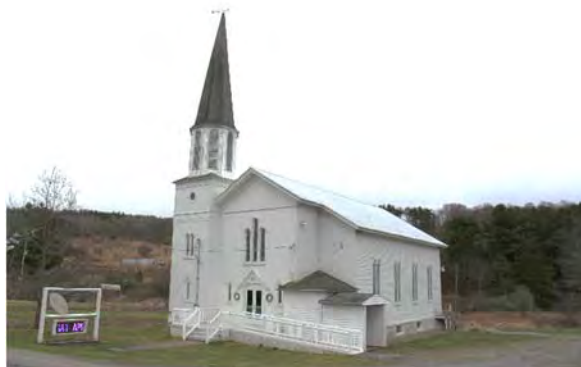
N/A	Church	Seventh Day Baptist Church (Chenunda Creek Fellowship Church)	CR 22	Independence	Allegany	N/A	Potentially eligible under Criterion Consideration A/Architecture. Built c. 1885, the Carpenter Gothic-style building with Italianate elements is the third meetinghouse at this rural crossroads site. It retains its original overall form, tower, belfry, spire, vertical board-and-batten gable, flush board and clapboard walls, and collection of single, paired, and triple stained glass windows featuring pointed gothic and round-arch openings with molded hoods. The tower features applied woodwork in a diamond and stylized egg-and-dart pattern. Alterations include aluminum and vinyl siding over the upper stage of the belfry, aluminum storm windows, a replaced front door; modern access ramp and enclosed side vestibule. While the building retains its integrity of location and setting, its integrity of design, materials, and workmanship are diminished by the alterations to its belfry and entry facade. These changes detract from the building's potential significance as a distinguished work of architecture and limit its feeling as an intact piece of rural church architecture with associations to the religious life in the community.	Not Eligible

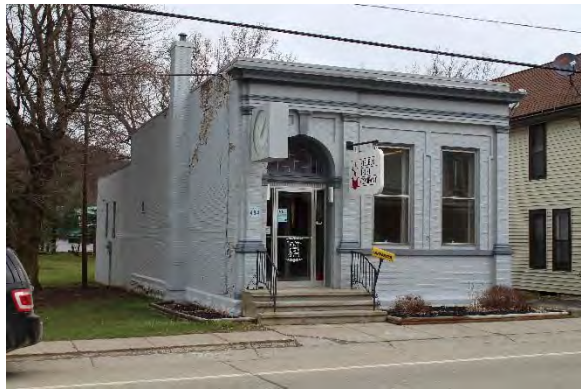
N/A	Commercial	First National Bank, Whitesville (Steuben Trust Company)	484 SR 248 Main Street	Independence	Allegany	N/A	Potentially eligible under Criterion C/Architecture. Built c. 1905, this Neoclassical Revival yellow brick (overpainted) building projects the images of stability and authority typically found in turn-of-the-century bank architecture. It retains its original general massing, brick façade, and arched transom window. Alterations include replaced parapet coping, replacement window sash and front door, replaced concrete stoop and handrails, altered side fenestration, a modern rear addition, and a coat of paint over the yellow brick. The changes to the windows and front entrance, in particular, diminish the building's integrity of design, materials, and workmanship. This detracts from the property's ability to convey the feeling of an early twentieth-century bank or its associations with bank design and construction.	Not Eligible

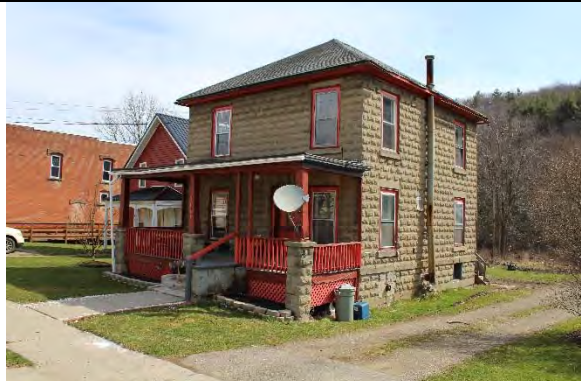
N/A			2680 SR 248 Main Street	Greenwood	Steuben	N/A	Potentially eligible under Criterion C/Architecture. Built c. 1910, this Foursquare dwelling resembles Design 52 available through the Sears, Roebuck and Company general catalogue. It retains its original form, molded cornice, rusticated cast concrete block walls and three of four porch plinths, smooth concrete window lintels and sills, water table, and tapered wooden porch posts. Significant alterations include the loss of one porch plinth and post, a rebuilt porch railing and steps, and replacement vinyl window sash. The alterations detract from its overall integrity of design, materials, and workmanship, while limiting its ability to convey the feeling of an intact early twentieth-century residence or its associations with the mail-order buildings.	Not Eligible

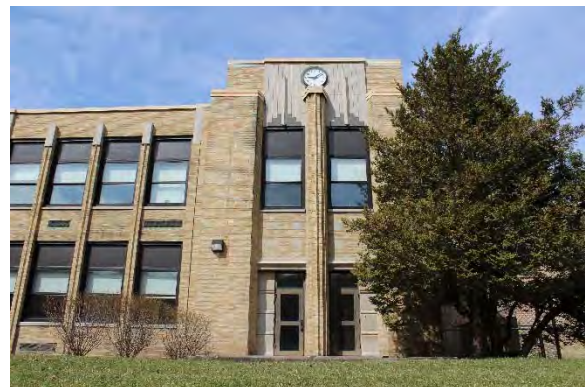
N/A	School	Greenwood Central School	2707 Hollywood Blvd	Greenwood	Steuben	N/A	Potentially eligible under Criteria A & C/Architecture; Education. Built c. 1935, the Art Deco Moderne brick and stone building includes Gothic elements often associated with educational buildings of the period. Built during the Great Depression, the building embodies Progressive-era educational principles of the day, including modern consolidated facilities, well-light classrooms, and forward-thinking design. The building core retains its original yellow brick walls, sandstone caps and ornament, buttresses, clock tower and clock. Sympathetically designed additions to the north and south suggest a building intended for expansion. More recent alterations, most notably the blocked up, resized, and replaced windows, replaced doors, relocated main entry, newer rear additions, and altered landscape, diminish the resource's integrity of design, setting, materials, and workmanship. The building is less able to convey the feeling of a Depression-era central school or its associations with the underlying theories in design and education.	Not Eligible

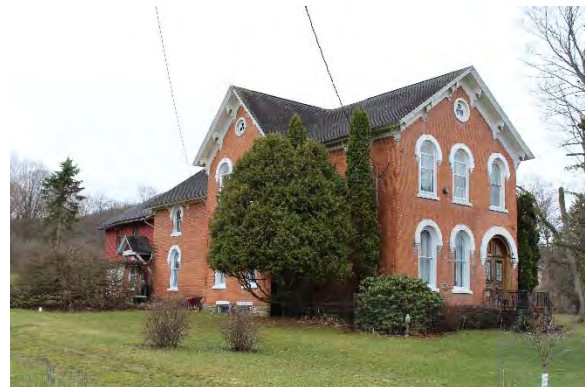
N/A	Residence		SR 248	West Union	Steuben	N/A	Potentially eligible under Criterion C/Architecture. Built c. 1880, the narrow front gable Italianate-style residence retains nearly all of its original fabric. This includes its overall form, decorative cornice, scrolled brackets, attic-story roundel windows with trefoil design, projecting arched window caps with keystone and corbelled drops, one-over-one and two-over-two wood window sash, two-leaf paneled front door, and high rusticated stone foundation. The building includes a c. 1900 wood frame rear addition, with original wood clapboard siding and wood sash windows. Scarring in the brickwork suggests the front door once included a porch roof. The front stoop and metal railing are later additions. Overall, the building is an excellent, intact example of its type and retains a high degree of integrity of location, design, setting, materials, and workmanship. It conveys the feeling of a late nineteenth-century prosperous village residence and its associations with the spread of popular architectural styles in rural Steuben County.	Eligible
